# Thermal Techniques

## **Cost and Savings With an Infrared Program**

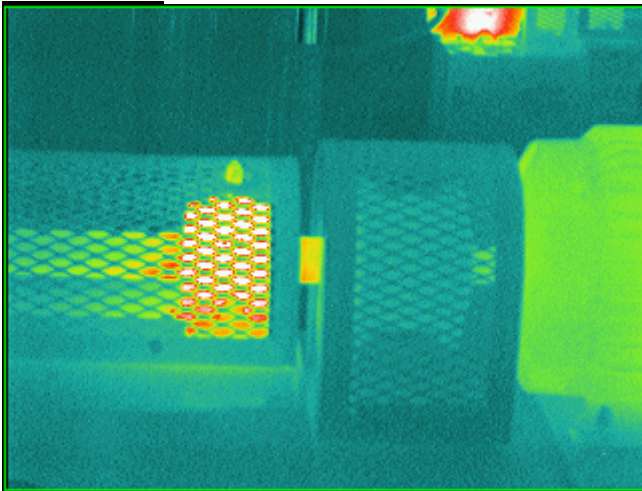
### **BEARINGS:**

This bearing is much warmer than the motor (on right of image). Note that the bearing guard did not have to be removed for quick and easy access by the thermal imaging team. If this had gone undetected this bearing would have ultimately failed. Failure would result in process interruption and force the emergency repair team into action. Failure could also cause shaft and fan damage, and necessitate new equipment having to be shipped in at a higher cost for a replacement unit. Thermal imaging allowed scheduled

downtime and easy repair to avoid catastrophic failure and dollar savings estimated at \$3000.00.

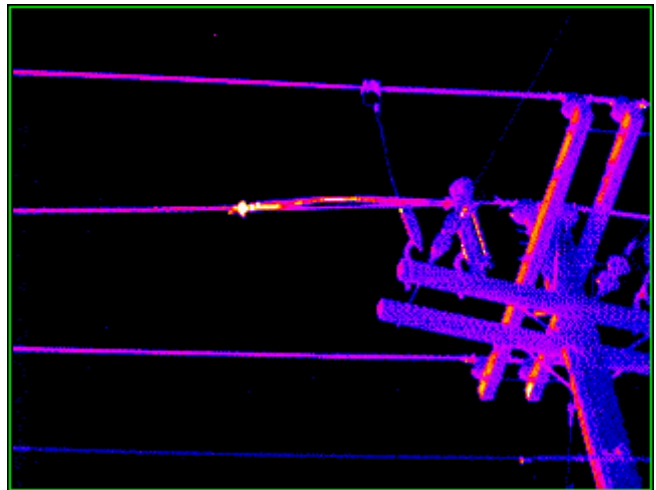
### **POWER LINE TO PLANT**

This image shows a power pole and a main transmission line to a plant site. The plant had experienced several voltage dips causing running equipment to loose power and shut down. The computer center at the site was affected the most as documents and data were lost during the voltage sags. Power company officials advised the loss of power was not on the grid and was probably inside the plant. Thermal imaging was employed on all transmissions lines to the site back to the substation serving the plant. This was a splice joint that had been installed due to downed lines from an ice storm several years earlier. The Thermal Imager was successfully used to locate the faulty wire splice. Power company officials

worked with the plant site staff to have a controlled outage so that the repair could be

made. At least 4 hours of plant shut down was avoided and cost savings were estimated to be in excess of \$25,000.00

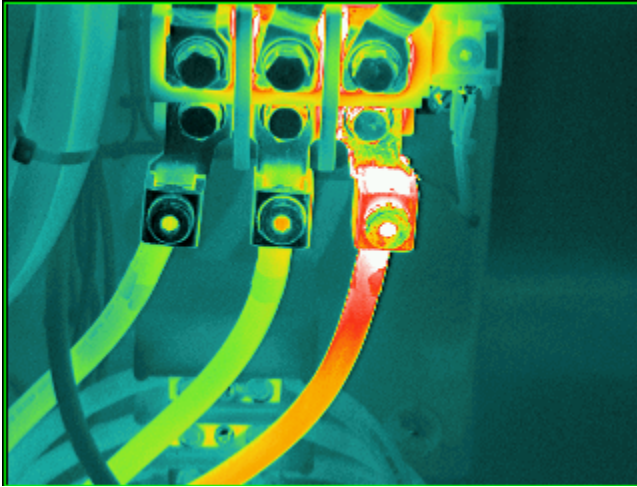
### **CONTACTOR – MOTOR STARTER:**

Motor contactors-motor starters are subjected to high inrush amps and it is critical that infrared inspections are used to find the numerous problems that can be found on these items. The above image clearly shows a faulty/loose connection at the bottom right lug connection. This contactor is used in an injection molding machine and the cost of down time is estimated at over \$800.00 per hour. Undetected failure could result in a loss of production in excess of 2 hours. In this instance thermal imaging informed plant personnel

that the wire on the right phase was probably damaged since the temperature exceeded 210F. In this manner a new wire was pulled from the motor to the contactor, and the offending wire was removed. All of this was scheduled during a mold change so no loss of production resulted. By replacing the wire, thermal imaging was able to assist in complete corrective action the first time as opposed to patching the problem during a production period and having to do additional repairs at a later date. Early detection also is credited with saving the contactor-starter from future damage. Estimated savings were \$2500.00.

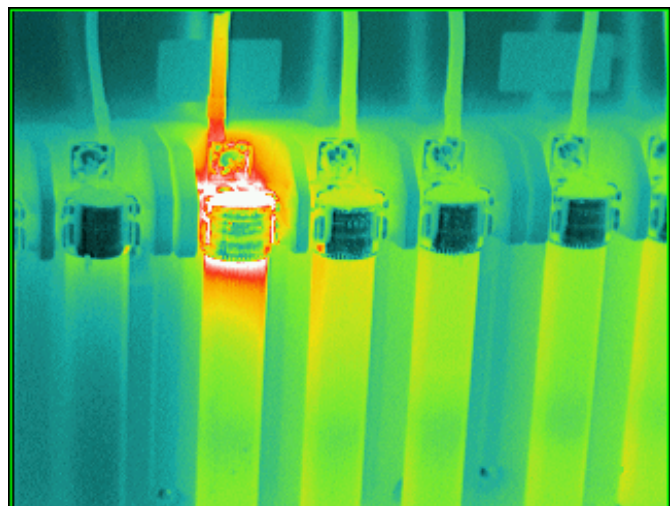
### **FUSES**

Quick and early detection of an electrical fault, such as this fuse clip, can help prevent overloading or a potential unbalance in a 3-phase load. This fuse, located in an oven control panel, controlled one of the heating sections within the oven. The curing process is one of time and temperature. If the heat is not correct for the proper time duration the quality of the product is adversely affected. This results in product rejects and production losses. Faulty fuse clips can cause early and premature fuse failure. Without the use of thermal imaging, Maintenance Personnel end up replacing the fuse on a continuing basis and never suspect that the root cause of the continued failure is the fuse clip and not the fuse or some other item in the electric circuit.
